# I. EXTERIOR MATERIALS

## A. CONCRETE

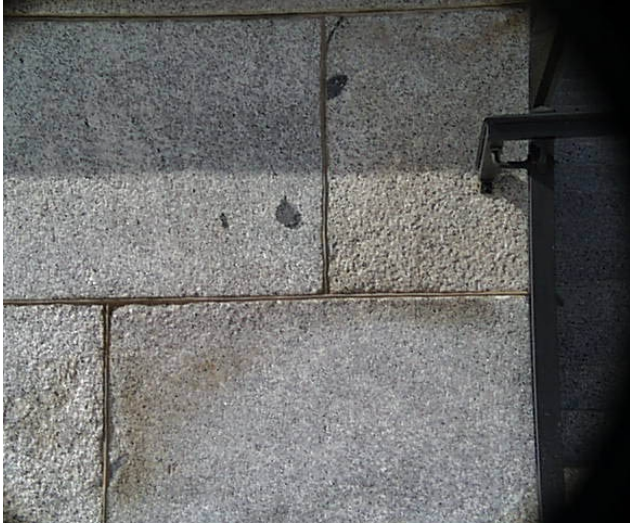
Some of the spalling appears due to the intrusion of water from rain, snow, and perhaps sheeting down the surface of the walls. As the water enters the porous cavities of the surface of the stone, it freezes and thaws during alternately cold and slightly warmer weather. As the water freezes, it expands and causes stresses within the stone that result in cracking, chipping or flaking of the stone in layers parallel to its surface.

Maintenance personnel believe that the spalling on the vertical surfaces of the column bases at the south entry has been caused by chemicals in the solutions used to clean or melt snow on the landing. Stone consultants confer that this is a likely possibility, since spalling does not appear to have occurred on similar vertical surfaces where cleaning and melting solutions have not been used.

Apply penetrating consolidants to the surface of spalling stone to better bind the surface particles, harden the stone and enhance its water-resisting characteristics. Research available products of companies such as ProSoCo and HMK to determine which are most chemically compatible and potentially effective with the stone.

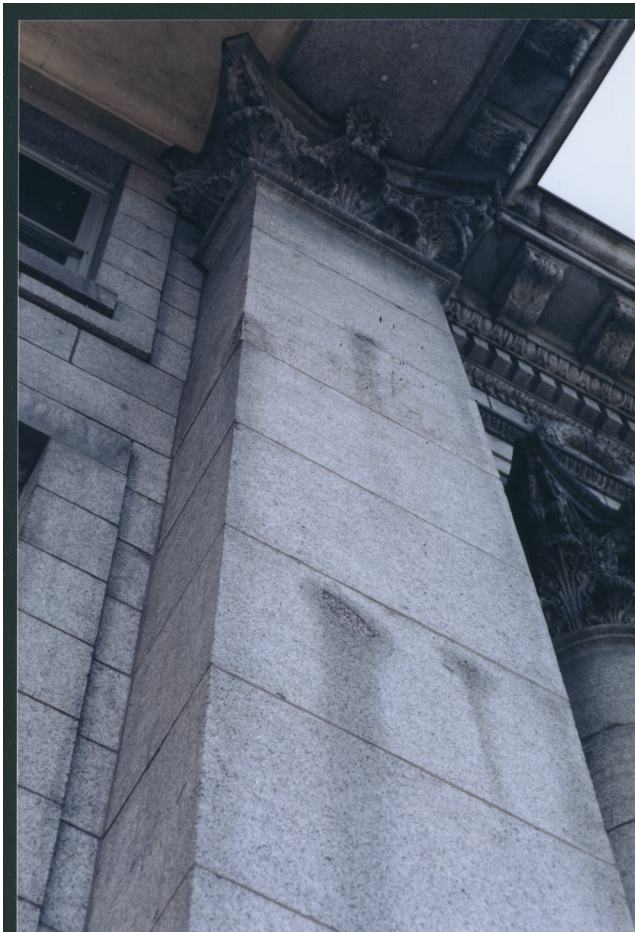
The dark gray or black spots are “inclusions” or xenoliths of unmelted gneiss material naturally embedded in the overall stone. The faces of the inclusions have been stippled by masons to expose the lighter aggregate within so as to tone down the darkness to better blend in with the lighter surface texture of the surrounding stone. However, like the patches, visible stains surround some of the inclusions. It is not known whether the staining occurred and then stopped early in the building’s history, or whether the staining process is still active. Or, again, the stains may be the result of applying a silicone-based sealant which has attracted pollution.

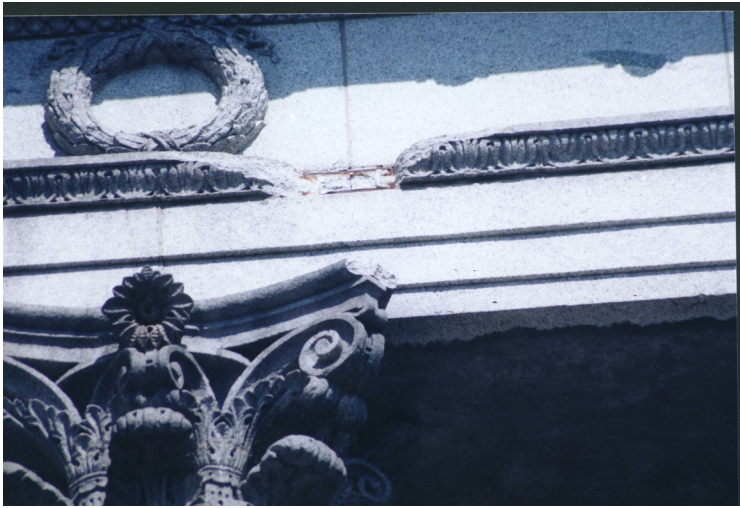
Another type of staining (yellow or reddish-brown) is likely the result of the aforementioned rusting of reinforcing metal in the stonework. Water leaking through the roof, flashing, parapets, or wind-driven into loose or missing mortar joints, may have caused rusting, in soluble form, has leached through the stonework

and deposited itself on exterior stone surfaces. This type of staining is thus more than just a visual problem since it may portend potential structural failure as well.

Grind out damaged mortar joints to expose underlying, embedded reinforcing metal to view. If the metal connectors have deteriorated, remove the stone, install new, stainless steel connectors embedded in epoxy, and reinstall the stone. If rust stains suggest deterioration which is not visible, conduct ferrous scans to determine if the diameter of the metal has expanded (rusting connectors expand and, like expanding ice, cause cracking). If the evidence suggests deterioration and potential structural failure, restore the stone pieces with new connectors as just described.

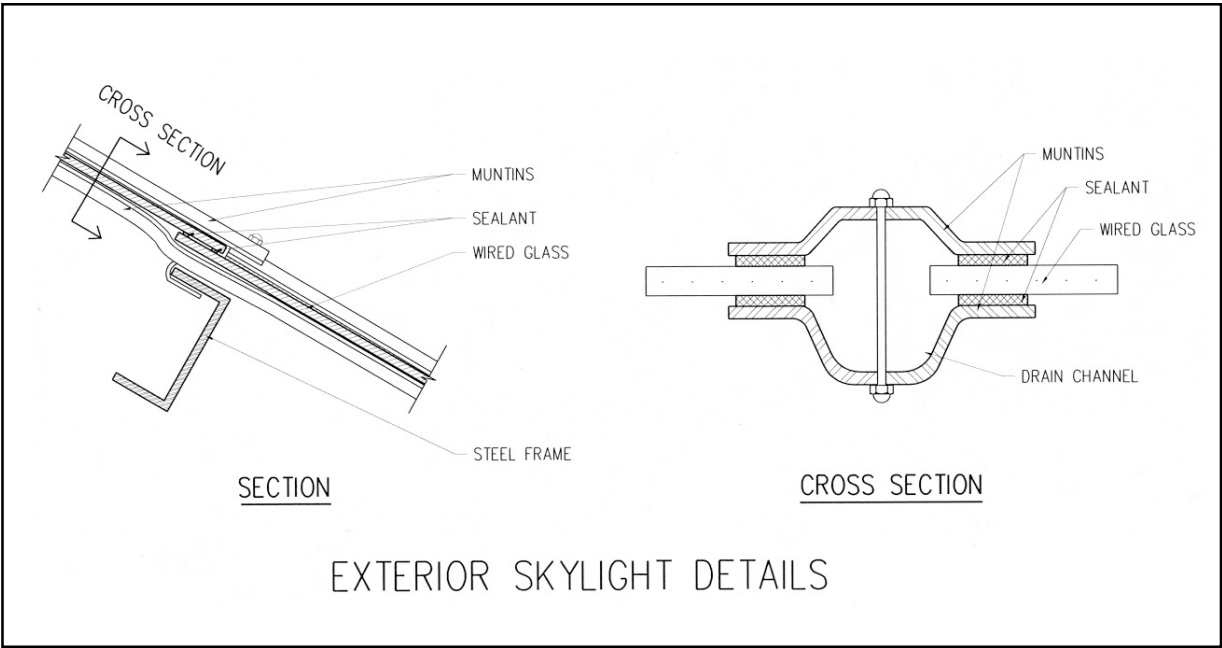
EXTERIOR SKYLIGHT DETAILS

- c) Exterior Skylight System: The wired glass panels overlap one another with caulking at the seams to prevent water infiltration. The upper muntins and lower muntins then sandwich wired glass with

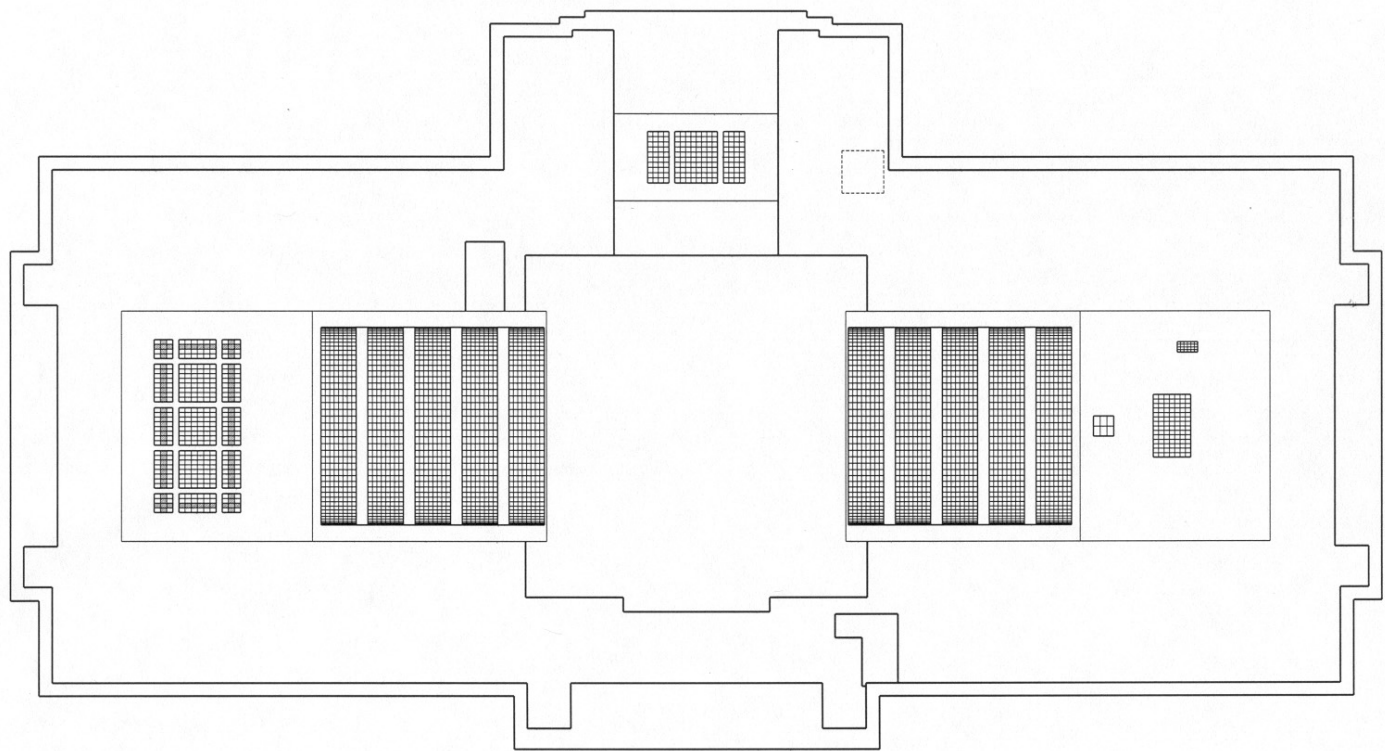
EXISTING INTERIOR SKYLIGHT PLAN

Artificial light fixtures are currently blocking daylight from penetrating skylights in the House of Representatives. These fluorescent lights were introduced to provide the House of Representatives with sufficient lighting day and night. It is inhibiting to natural lighting to retain these fixtures.

The attic above the Supreme Court is unclean and unkempt. The butt insulation covering the attic floor has rotted and at one point covers a 3'x 6' skylight. This is one of several small skylights indicated on the 1916 plans surrounding the Supreme Court Chamber. The interior skylight glass above the Supreme Court Chamber has been entirely replaced by fiberglass and is not sealed airtight. The thin fiberglass does nothing to protect the space below from falling objects.
